RE: Safety Bulletin on KMG and Report requirements for Freakout ride to operate in North Carolina.

Bulletin No:	FRB16-SB002
Release Date:	October 21 <sup>st</sup> , 2020
Effective Date:	October 21 <sup>st</sup> , 2020
Supersedes:	none
Completion Date:	See text
Page:	1 of 7

# SAFETY ALERT

<b>Ride Mfg:</b>	KMG International BV	<b>Affected Production Dates:</b>	All
<b>Ride Name:</b>	Freak-Out	<b>Affected Serial Numbers:</b>	01 through 51
<b>Model Number:</b>	FRB16		
<b>Abstract of Issue:</b>	Immediate NDT inspection on gondola sweep hub

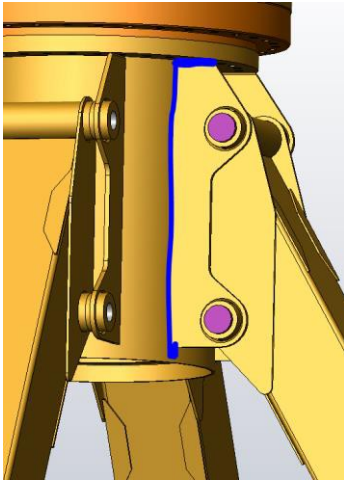
Areas A:

1. The sweep arm hub is to be cleaned and all loose parts are to be removed, until the exterior surface of sweep hub can be inspected.
2. Visually inspect the weld and especially the corners of the sweep hub where the support plate joins the round tube (Areas A), looking for visible cracks. The sweep hub has 8 of these areas, inspect both sides of the areas.
3. Visually inspect the round thickening plates of the sweep hub where it joins to the support plate (Areas B), looking for visible cracks. The sweep hub has 16 of these areas, inspect both sides of the areas.

**Accepted:** No cracks or indications are visible under normal vision. Repeat the visual inspections on a weekly basis, until Procedure B has been completed.

**Rejected:** Cracks or indications are visible under normal vision.  
Do not attempt to repair. **Do NOT operate the ride.**  
Contact KMG International BV

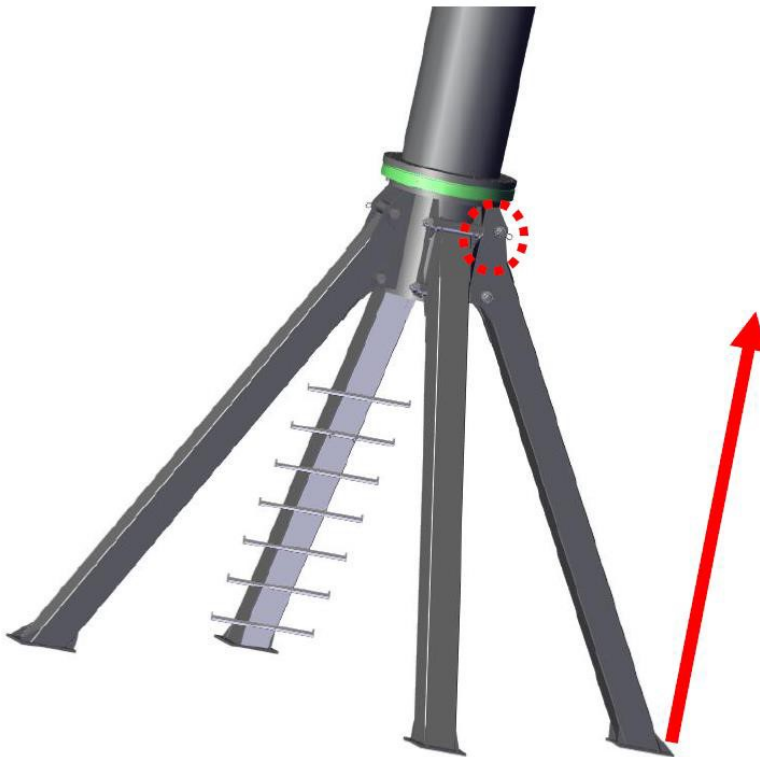
1. Use chain hoist or ride winch to lift the gondola arm.

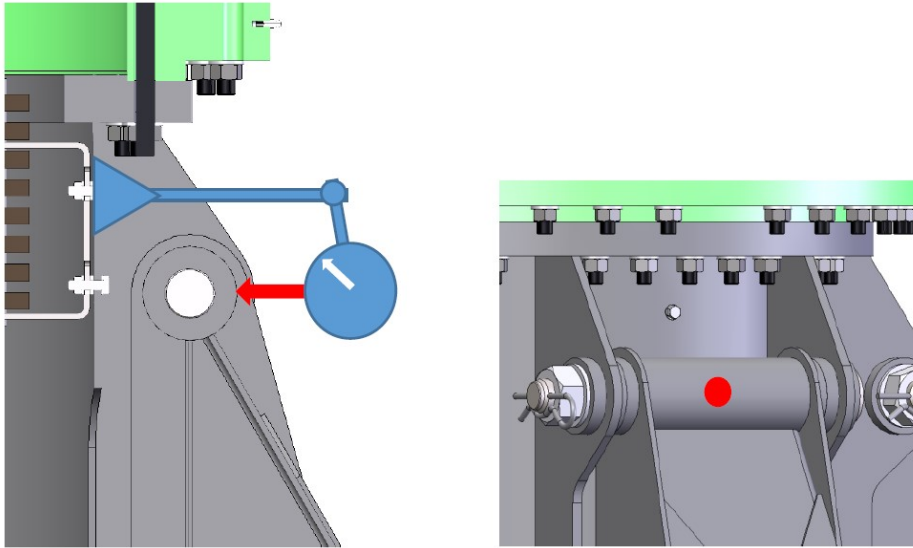
2. Install dial indicator between sweep hub and gondola arm on top of sweep hub:

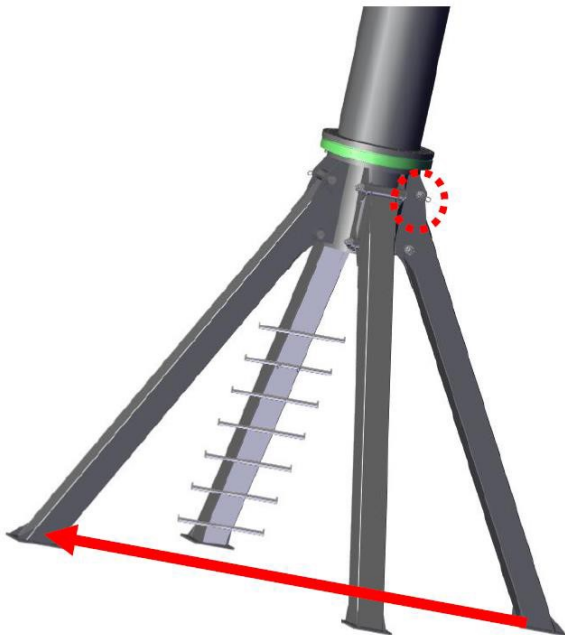
3. Lower gondola arm and use the chain hoist to pull the gondola arm to the opposite gondola arm

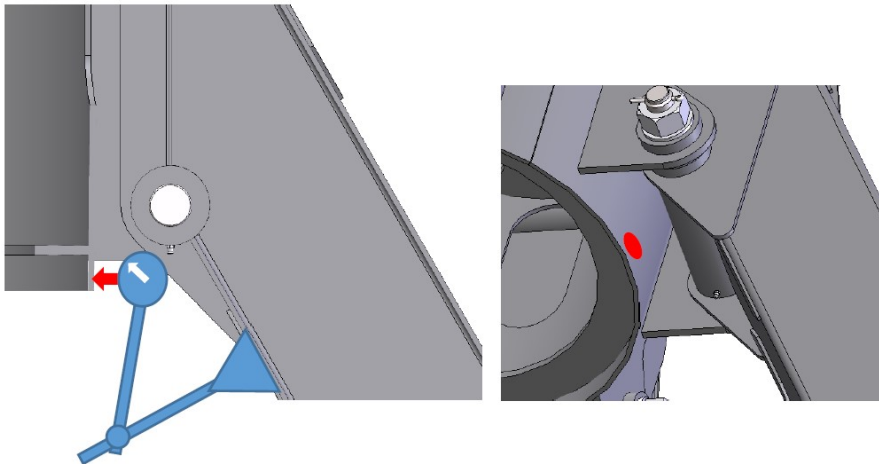
4. Read out play indicator at the dial indicator; this is measurement A.
5. Keep chain hoist of step 3 in place.
6. Remove dial indicator from top and install indicator between sweep hub and gondola rm on bottom side of sweep hub:

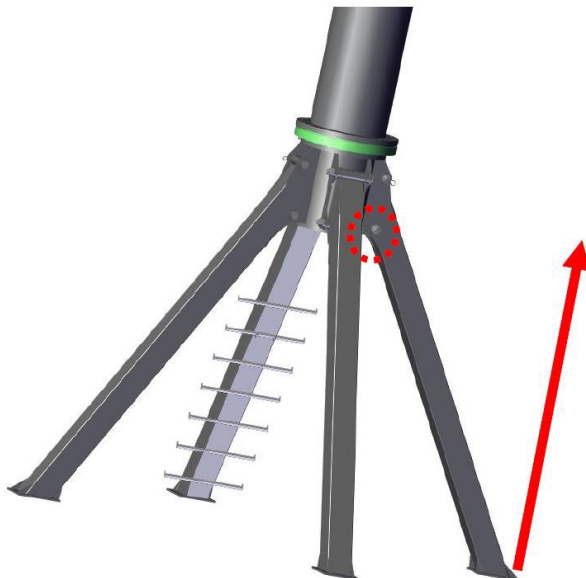
7. Remove chain hoist from opposite arm and lift gondola arm with chain hoist or ride trailer winch:

Accepted: Measurements A and B are smaller than 0.5mm.

Rejected: Any measurement A or measurement B larger than 0.5mm.
